Manhole Inspection Summary

Manhole # S33II_009MH

Insp Date: **3/30/07 12:20 PM**

Location Address: **1727 LOVEGROVE ST**

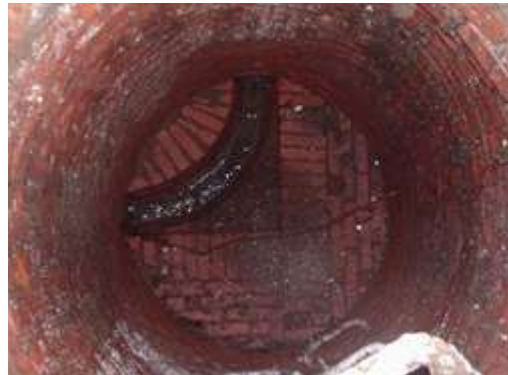
Top View

Bench ☒ Exists Material: **Brick** ☐ Parged ☒ **Debris** (not Condition related)

Steps Count: **5** Missing: **0** ☒ **Corroded**

Surcharge ☒ **Evidence Of Surcharge** Depth: **1** (ft.) ☐ Active Surcharge Present

Corroded steps. Evidence of surcharge - Bench debris. .

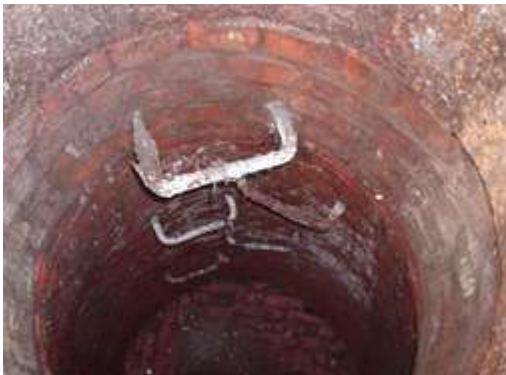
Defect

Condition: ☐ Sound ☐ Cracked ☐ Root Intrusion ☐ Loose Brick ☒ **Deteriorated**

Infiltration: ☐ None ☒ **Joint** ☐ Cracks ☒ **Mortar** ☐ Roots ☐ Wall

Infiltration: ☐ None ☐ Joint ☐ Cracks ☒ **Mortar** ☐ Roots ☒ **Wall**

Adjustment and Corbel infiltration.

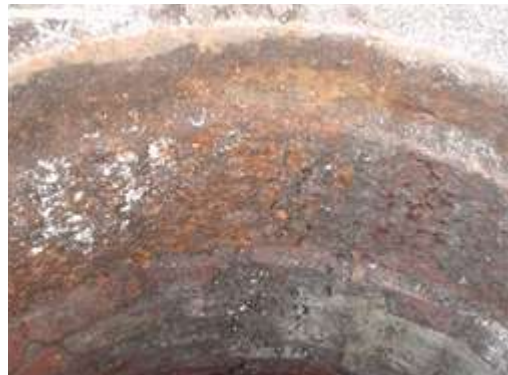
Defect

Adjustment deterioration and infiltration.

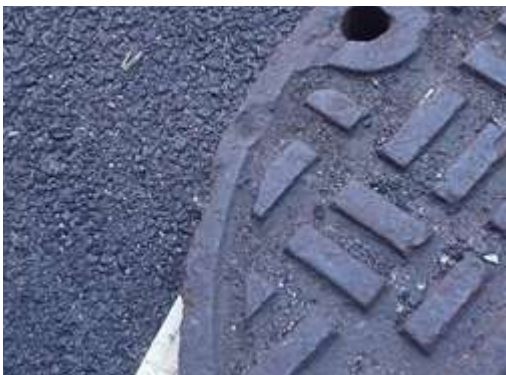
Defect

Condition: **Worn**

Worn cover.

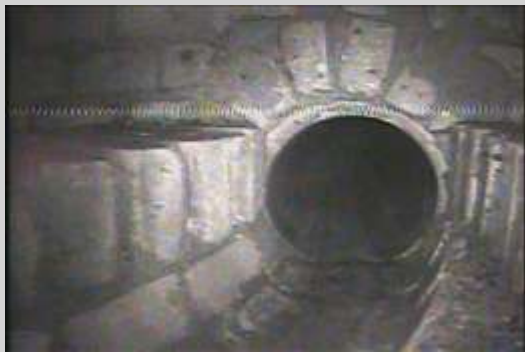
8 in. Circular Gravity Sewer Pipe Out @ 12 O'Clock

Infiltration: **None** Pipe Seal Cond: **Cracked**

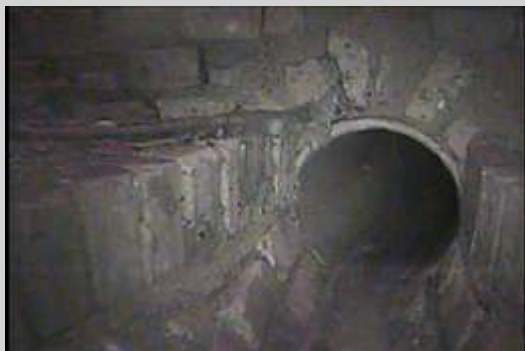
8 in. Circular Gravity Sewer Pipe In @ 9 O'Clock

Infiltration: **None** Pipe Seal Cond: **Broken**
